CLOSED LANDFILL INVENTORY

CORYELL COUNTY

CENTRAL TEXAS COUNCIL OF GOVERNMENTS CLOSED LANDFILL INVENTORY

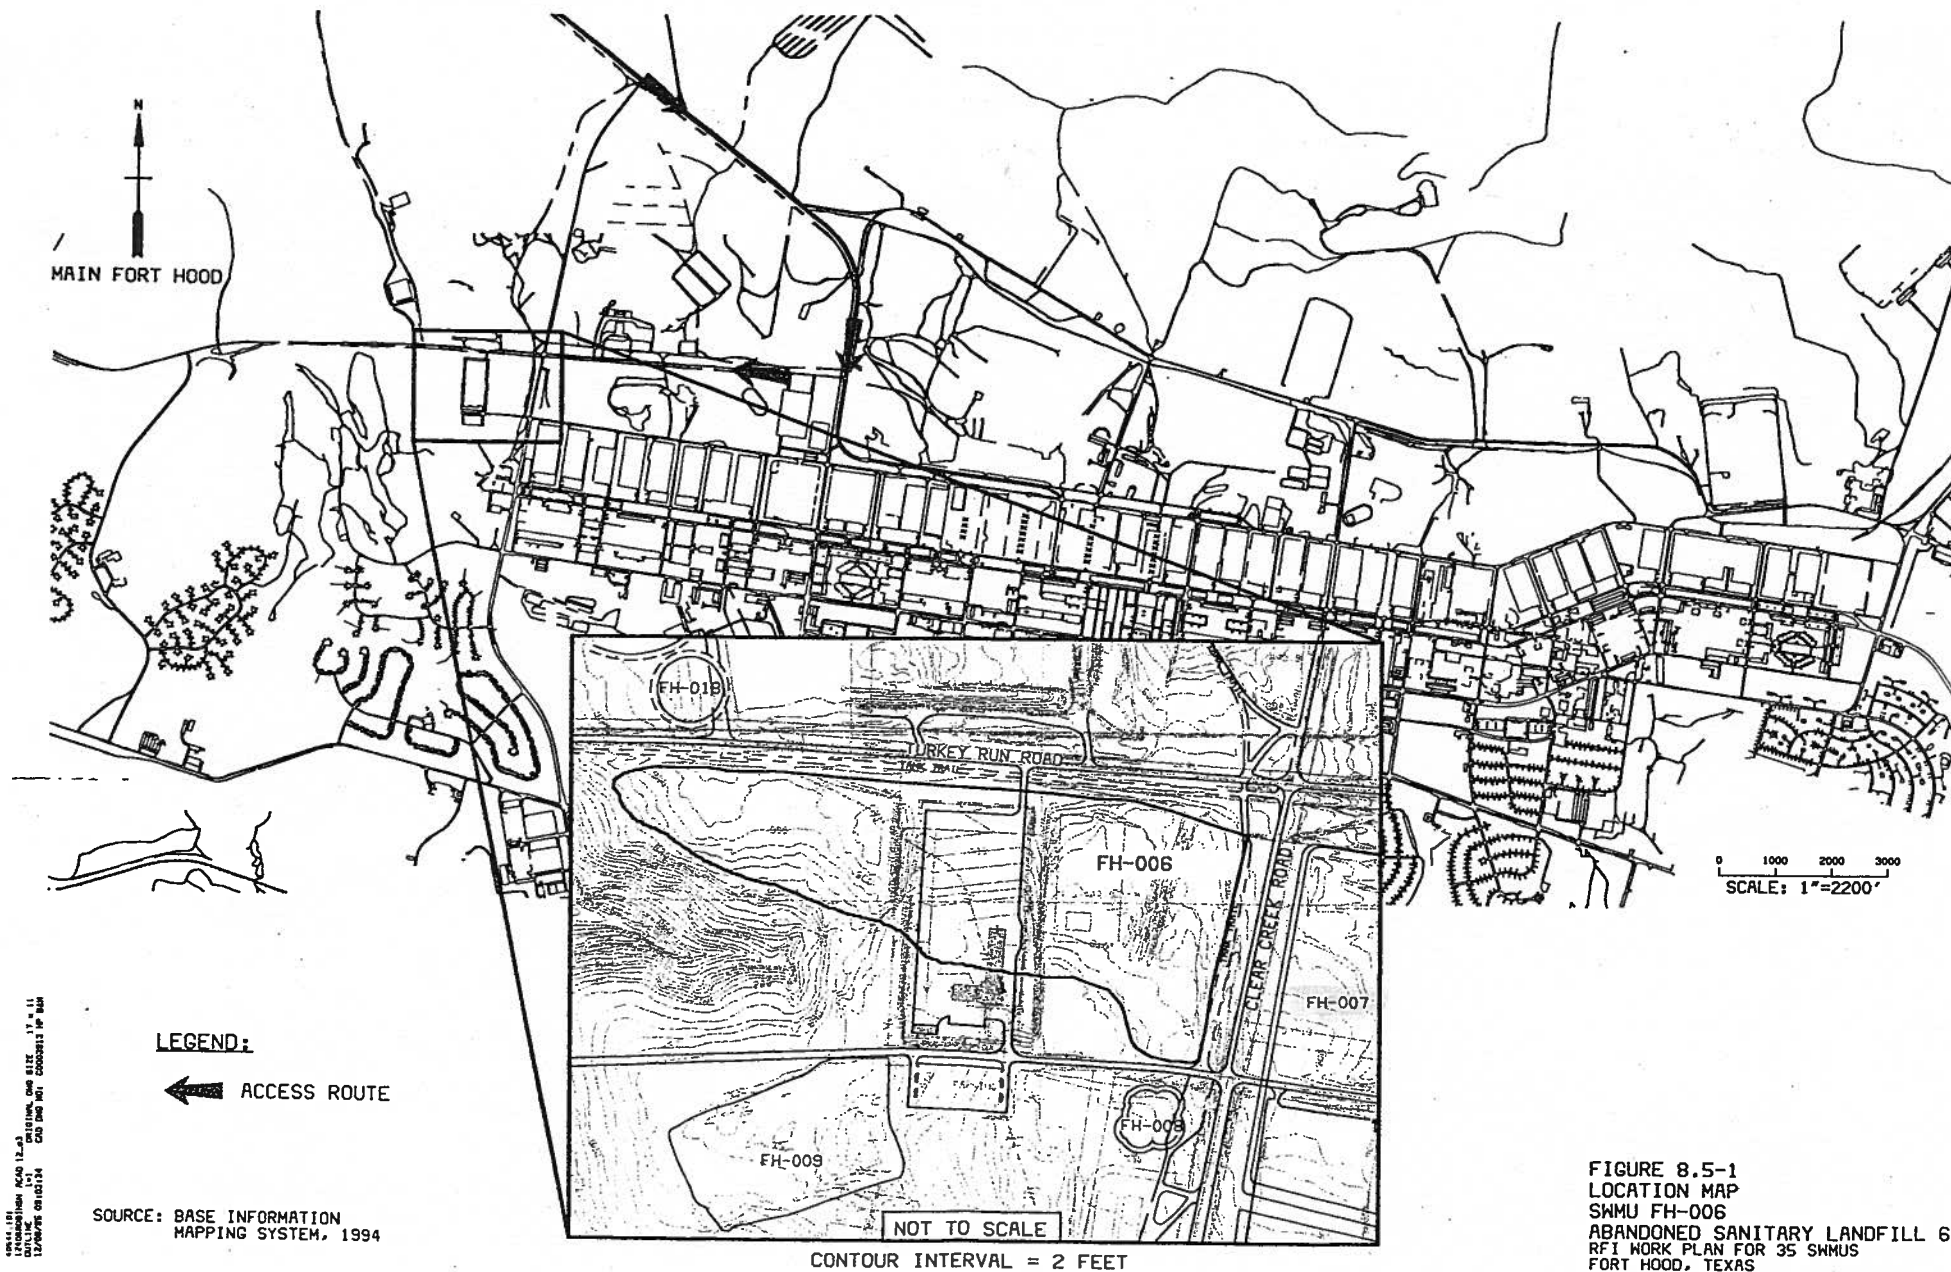
8.6.6.1 Subsurface Soil Pathway. The subsurface soil pathway is an important potential migration pathway because the landfill may have been constructed in native soil without an adequate liner. As a result, the subsurface soils can act as a long-term source of contaminants to other media. Contaminant release to groundwater can occur through leaching during periodic storm events that produce infiltration or
